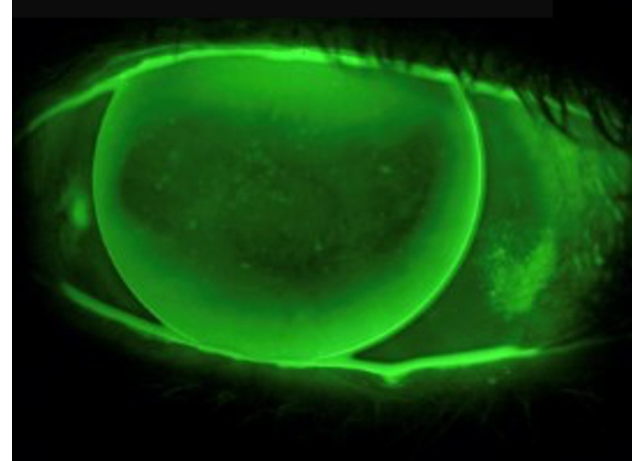
9.80mm aspheric causing 3&9 staining

NaFl stain at 3&9, area under stain becomes opaque and raised as advances.

Combination of lens fit (usually immobile), tear film quality and reduced lid wipe effect adjacent to lens.

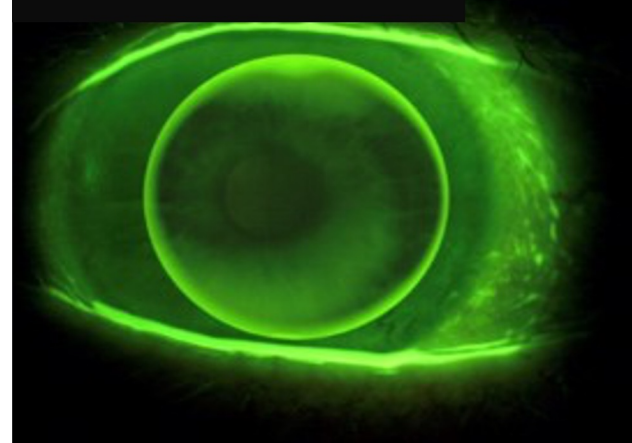
Refitted with 8.30mm multicurve

Reduce lens diameter by 1.0 or 1.5mm.
